Overview of the Structural Design of World Trade Center 1, 2, and 7 Buildings

Abstract: This paper summarizes the primary structural systems that comprised World Trade Center 1, World Trade Center 2, and World Trade Center 7, which were destroyed in the terrorist attacks of September 11, 2001. There were four major structural subsystems in the towers: the exterior walls, the core, the floor system, and the hat truss. The major structural systems within WTC 7 were the foundation, exterior moment frames, floor system, interior columns, and column transfer trusses and girders. At the time of design and construction, the World Trade Center (WTC) towers were innovative in many ways, and resulted in a tremendous increase of open-plan commercial office space in downtown Manhattan. As the first of four papers, this paper summarizes the structural and passive fire protection features of each building, and focuses on the structural systems which played a critical role in the outcome of the attacks of September 11, 2001. Three companion papers address the effects of aircraft impact damage on the WTC towers and debris damage on WTC 7, the effects of fire on the three buildings, and how these

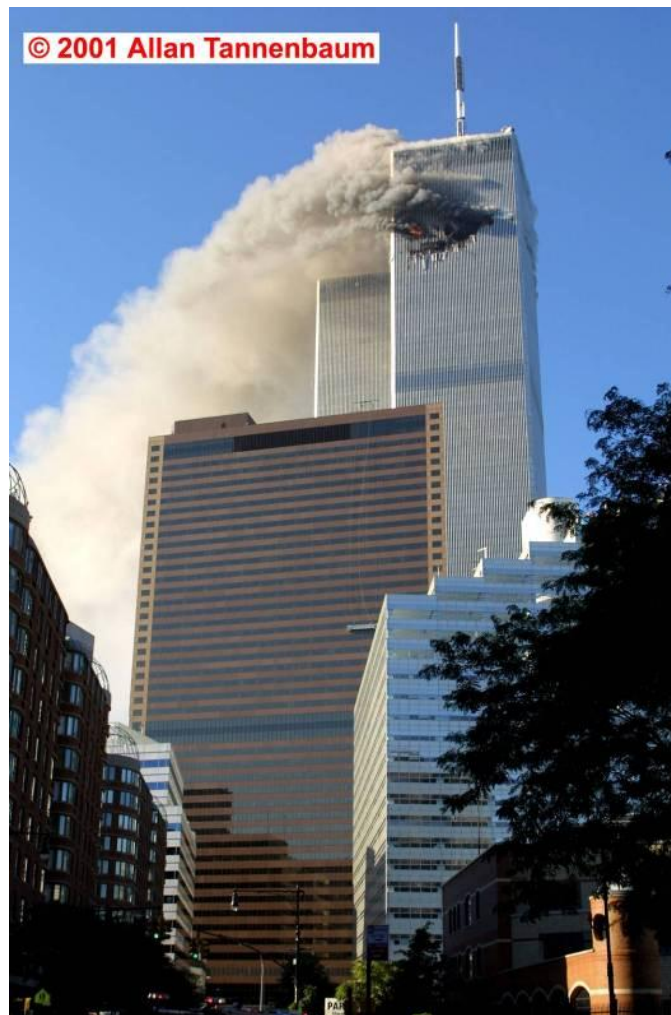
Figure 8. WTC 7 viewed from the north [4].

WTC 7 was trapezoidal in plan with dimensions of approximately 100 m (329 ft) on the longer side, 75 m (247 ft) on the shorter side, 43 m (140 ft) wide, and 186 m (610 ft) high. The building was constructed over a pre-existing electrical substation owned by Consolidated Edison (Con Edison). The original plans for the Con Edison substation included a high-rise building, and the foundation was sized for the planned structure. However, the final design for WTC 7 had a larger footprint than originally envisioned and accommodations were made in the foundation [4]. Over the years, numerous structural modifications were made throughout the building, mainly to suit its largest tenant, Salomon Brothers Inc., later to become Salomon Smith Barney, and now Citigroup. One of the modifications was the addition of a roof penthouse, referred to as the east penthouse, which was used to house a chiller plant and cooling towers for Salomon Brothers. Also, large portions of Floors 41 and 43 were removed on the east side of the building to accommodate trading floors for Salomon Brothers. The removed floor areas were subsequently restored after the trading activity was moved to another venue. The following sections provide a brief overview of the primary structural systems of WTC 7.

WTC 7 was a 47 story commercial office building located immediately to the north of the main WTC complex, see Figure 8. It occupied the block bounded by Vesey Street on the south, Barclay Street on the north, Washington Street on the west, and West Broadway on the east (see Figure 1). Located approximately 105 m (350 ft) from the north side of WTC 1, it was connected to the WTC complex by a 36.6 m (120 ft) wide elevated plaza and a 6.7 m (22 ft) wide pedestrian bridge at the 3rd floor level. Its location relative to the WTC Plaza is shown in Figure 1. WTC 7 contained approximately 186,000 m² (2 million ft²) of floor area.
